THERMOGRAPHIC INSPECTION REPORT

Customer: ABC Company

Project: C085

Equipment ID: EM LP-1 Phase 1

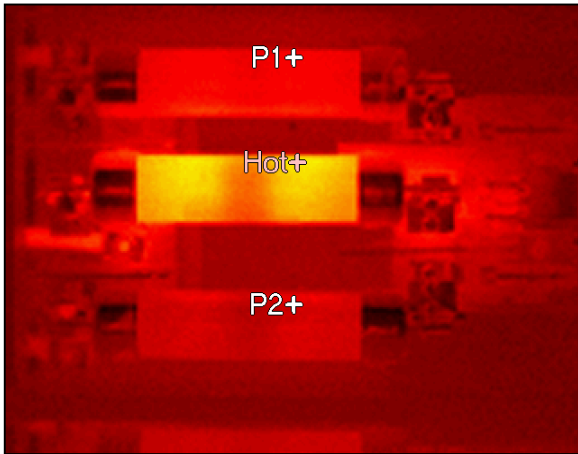
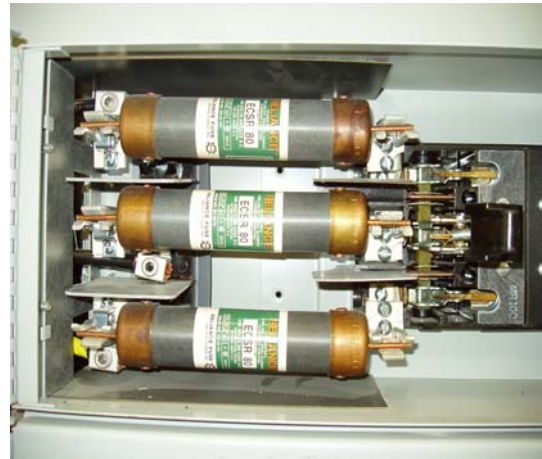
Problem Description:

Unbalanced Center Phase. Current Measurements:(16.7A,42.7A,22.3A)

(P) Point Temperature	
(P1) Temp	(P2) Temp
87°F	85°F
Hot Temp	103°F

ACTION REQUIRED		Probable Cause		Recommended Action	
	Deficiency, Investigate		Loose Connection		Secure Power
x	Schedule Repair at next outage		Oxidation of Conn		Clean/Tighten Connection
	None: Problem corrected during inspection		Overloaded Circuit		Determine cause of Imbalance
	Repair and Verify with Infrared Inspection	X	Unbalanced Circuit	X	Distribute Load Evenly
			Failing (bad) Fuse		Determine Cause of Overload
			Failing Breaker		Reduce Load below 80% FLA
			Code Violation		Replace Conductors
					Replace Fuses
					Replace Bus
