THERMOGRAPHIC INSPECTION REPORT

Project: C085

Equipment Location: Room L-245

Equipment ID: Norm Pwr Disc. ATS 1 EM-1

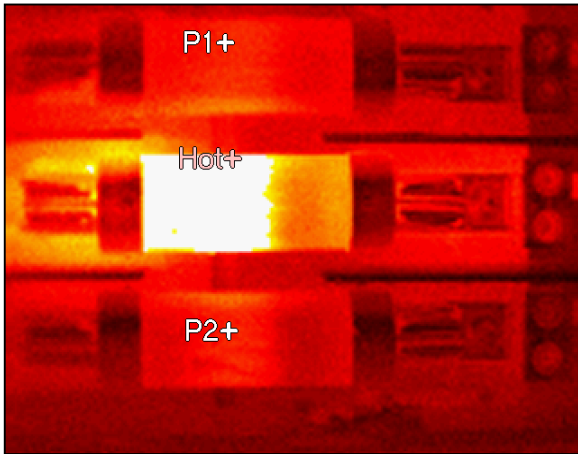
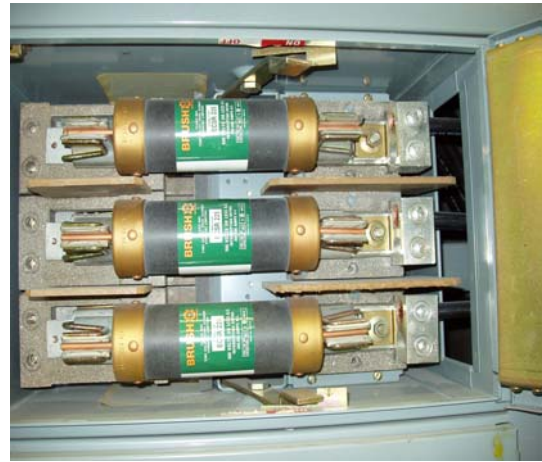
Unbalanced Circuit. Measured Current: (48A,98A,68A)

(P) Point Temperature	
(P1) Temp	(P2) Temp
84°F	84°F
Hot Temp	96°F

ACTION REQUIRED		Probable Cause		Recommended Action	
	Deficiency, Investigate		Loose Connection		Secure Power
x	Schedule Repair at next outage		Oxidation of Conn		Clean/Tighten Connection
	None: Problem corrected during inspection		Overloaded Circuit		Determine cause of Imbalance
	Repair and Verify with Infrared Inspection	X	Unbalanced Circuit	X	Distribute Load Evenly
			Failing (bad) Fuse		Determine Cause of Overload
			Failing Breaker		Reduce Load below 80% FLA
			Code Violation		Replace Conductors
					Replace Fuses
					Replace Bus
