## Midwest Electrical Consultants

### THERMOGRAPHIC INSPECTION REPORT

Project: C085

Equipment ID: MCC T

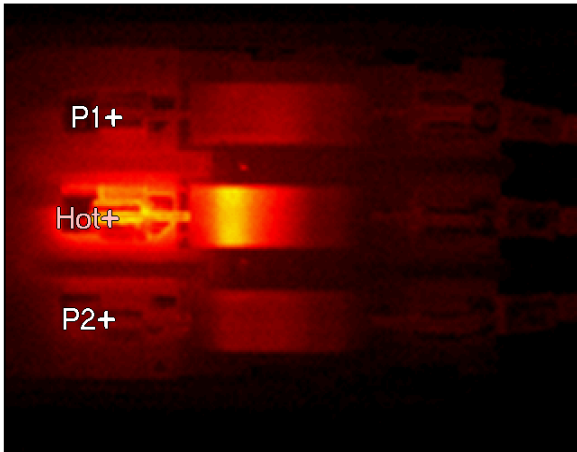
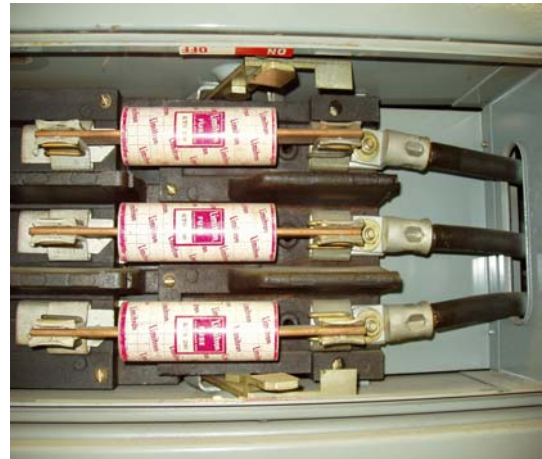
Hot Fuse Clip. Current Measured: (40.1A,36.6A,40.3A)

(P) Point Temperature	
(P1) Temp	(P2) Temp
83°F	83°F
Hot Temp	106°F

ACTION REQUIRED		Probable Cause		Recommended Action	
	Deficiency, Investigate	X	Loose Connection		Secure Power
	Schedule Repair at next outage	X	Oxidation of Conn	X	Clean/Tighten Connection
	None: Problem corrected during inspection		Overloaded Circuit		Determine cause of Imbalance
X	Repair and Verify with Infrared Inspection		Unbalanced Circuit		Distribute Load Evenly
			Failing (bad) Fuse		Determine Cause of Overload
			Failing Breaker		Reduce Load below 80% FLA
			Code Violation		Replace Conductors
					Replace Fuses
					Replace Bus
