THERMOGRAPHIC INSPECTION REPORT

Customer: ABC Company

Project: C085

Equipment ID: LP-ALAL-3 120/208V Panel

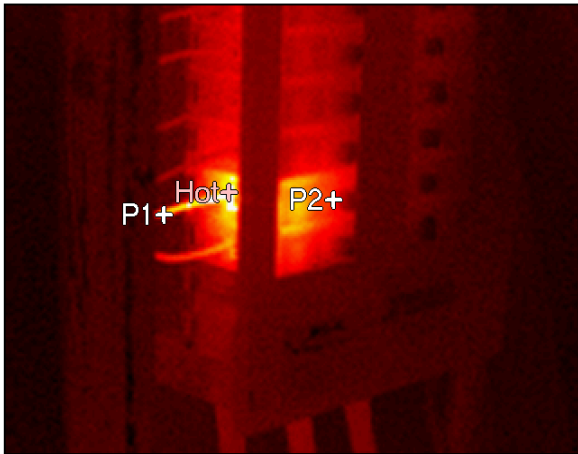
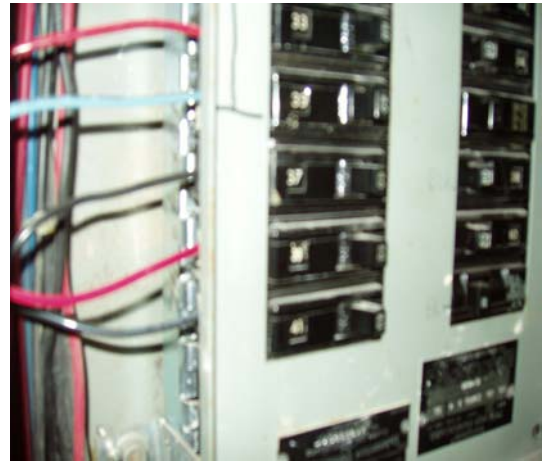
Hot Termination on 20AF Breaker Position #39. Measured Current:(14.3A)

(P) Point Temperature	
(P1) Temp	(P2) Temp
95°F	95°F
Hot Temp	114°F

ACTION REQUIRED		Probable Cause		Recommended Action	
	Deficiency, Investigate	X	Loose Connection		Secure Power
x	Schedule Repair at next outage	X	Oxidation of Conn	X	Clean/Tighten Connection
	None: Problem corrected during inspection		Overloaded Circuit		Determine cause of Imbalance
	Repair and Verify with Infrared Inspection		Unbalanced Circuit		Distribute Load Evenly
			Failing (bad) Fuse		Determine Cause of Overload
			Failing Breaker		Reduce Load below 80% FLA
			Code Violation		Replace Conductors
					Replace Fuses
					Replace Bus
