## THERMOGRAPHIC INSPECTION REPORT

Project: C085

Equipment Location: Penthouse #4

Equipment ID: MCC Fan F-19

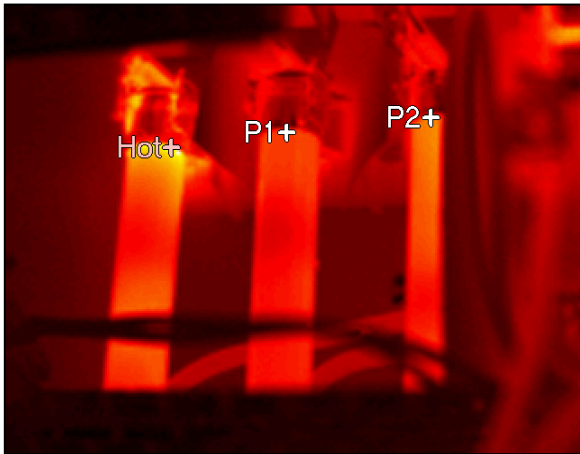
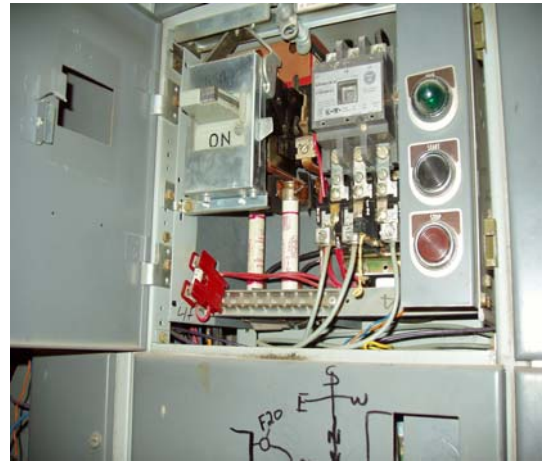
Top Left Fuse Clip Hot. Measured Current:(19A,19A,19A)

(P) Point Temperature	
(P1) Temp	(P2) Temp
126°F	135°F
Hot Temp	156°F

ACTION REQUIRED		Probable Cause		Recommended Action	
	Deficiency, Investigate	X	Loose Connection		Secure Power
x	Schedule Repair at next outage	X	Oxidation of Conn	X	Clean/Tighten Connection
	None: Problem corrected during inspection		Overloaded Circuit		Determine cause of Imbalance
	Repair and Verify with Infrared Inspection		Unbalanced Circuit		Distribute Load Evenly
			Failing (bad) Fuse		Determine Cause of Overload
			Failing Breaker		Reduce Load below 80% FLA
			Code Violation		Replace Conductors
					Replace Fuses
					Replace Bus
